Confidential Inspection Report
456 Any Road
Carlisle, PA 17013

Prepared for: Mr. Joe Example

Prepared by: Mid Penn Home Inspections
P.O. Box 1036
Carlisle, PA 17013
717-226-3066 info@midpennhomeinspections.com

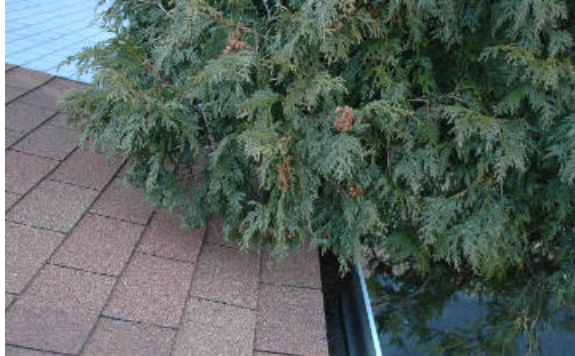
Bushes and shrubs need to be trimmed away from the structure at least 2 inches. This space is needed to prevent direct access to the structure by insects and to keep the bushes from damaging the siding.

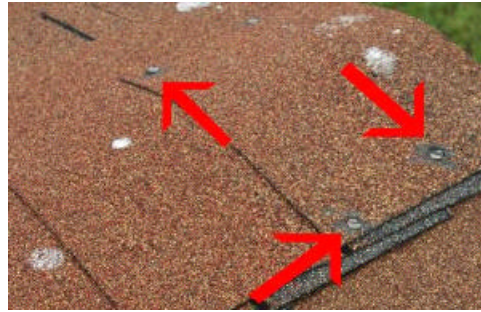
Condition of Roof Covering Material:

There is face nailing on some of the shingles. This promotes leaks at the nails and should be corrected.

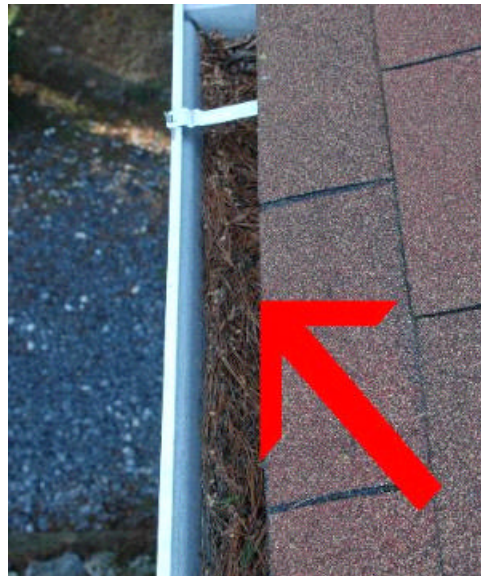
Roof Gutter System:

Attention Needed - The downspouts appear to be clogged and need attention to function normally.

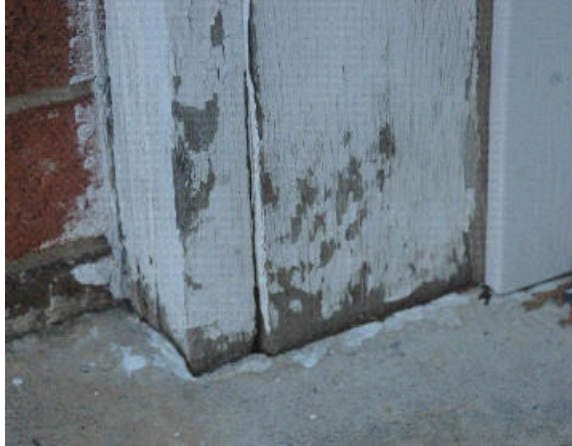
Attention Needed - The trim needs some minor repair to prevent further deterioration. Some portion of the trim boards needs some painting to prevent further deterioration.

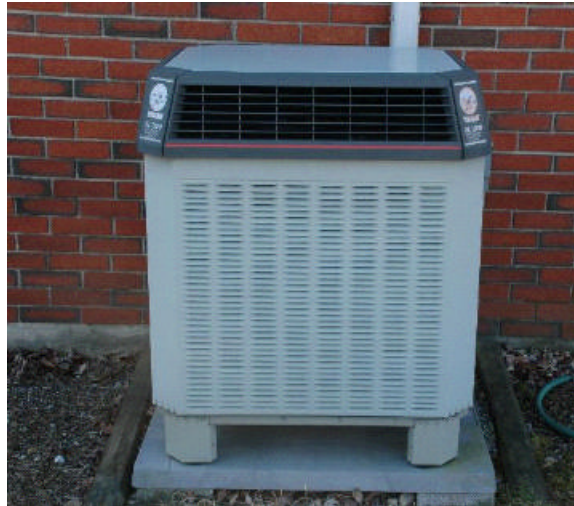
Unit/Condenser Location:

Side of house.

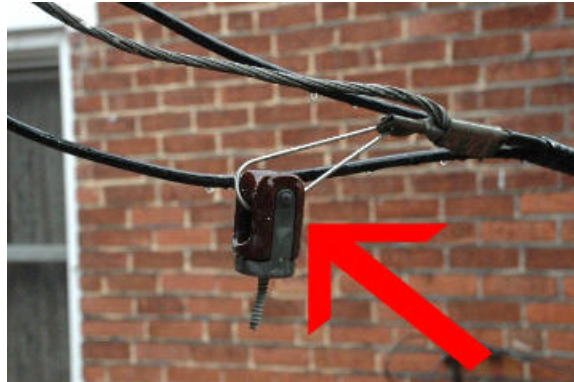
Service/Entrance/Meter:

The mast is not secure to the structure. Action is needed to make the mast secure to the building. Contact a qualified electrician for necessary repairs.

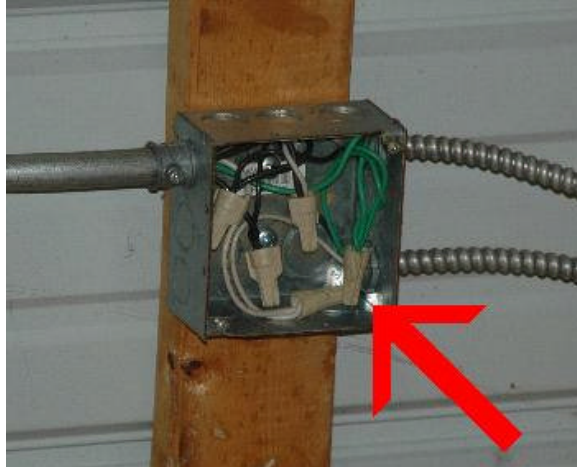
Wire Protection/Routing:

Action Necessary - It is recommended that some portions of the visible wiring be reinstalled or secured. A safety hazard may exist. Services of a qualified licensed electrician are needed. Wire splices should be made in covered junction boxes.

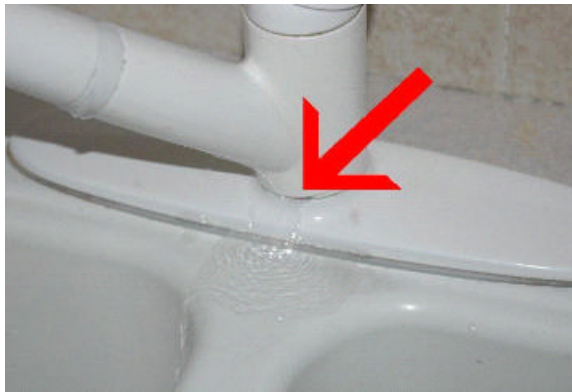
Attention Needed - The kitchen faucet leaks. Attention is needed. Contact a qualified plumber for necessary repairs.

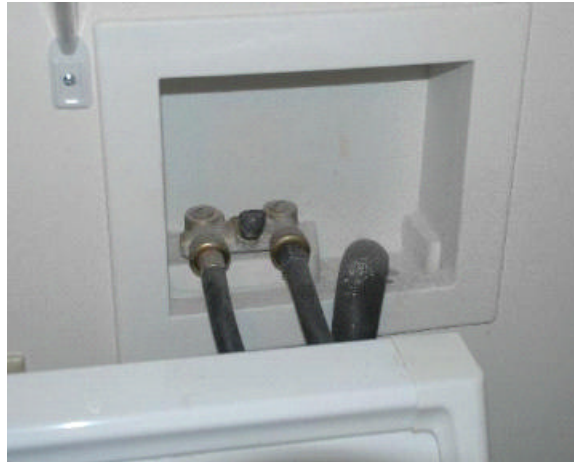
There is a connection box installed in the wall with both hot and cold water and a drain pipe.

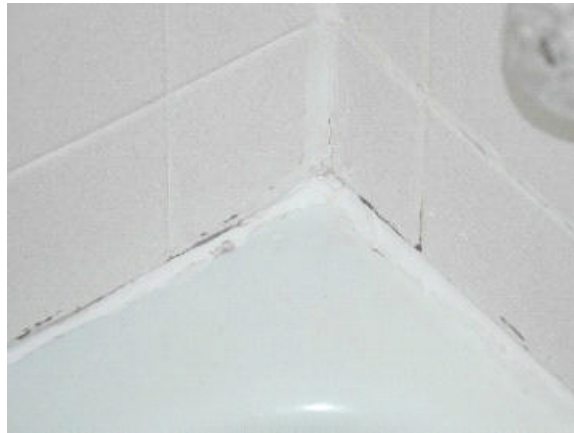
Attention Needed - The caulking in the water contact areas appears to need attention. Damage may result if not corrected.

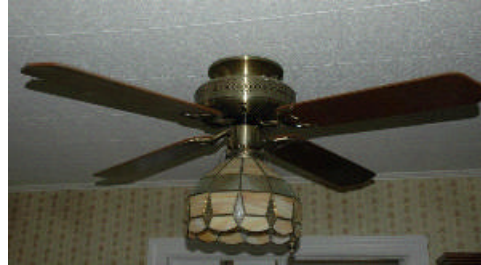
Ceiling Fans:

Attention Needed - The ceiling fan installed in the master bedroom appears to need some adjustment. The fan blades wobble. Apparently the blades need to be balanced.

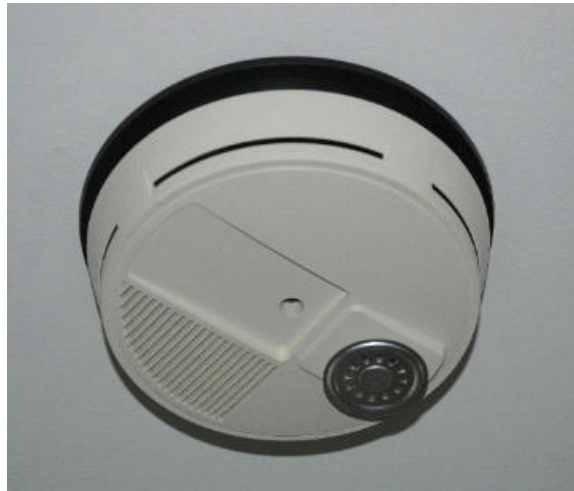
Smoke Detector:

For safety reasons, it is recommended that a smoke detector be installed on every floor and in every bedroom. It is also recommended that a carbon monoxide detector be installed on every floor.

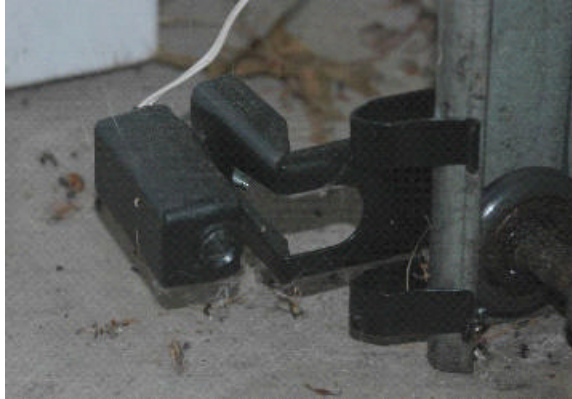
Yes - The door opener is equipped with an automatic reverse safety switch. There is an electronic beam safety reverse system installed. It appears to be functional.
