Confidential Inspection Report
456 Any Road
Carlisle, PA 17013

Prepared for: Mr. Joe Example

Prepared by: Mid Penn Home Inspections
P.O. Box 1036
Carlisle, PA 17013
717-226-3066 info@midpennhomeinspections.com

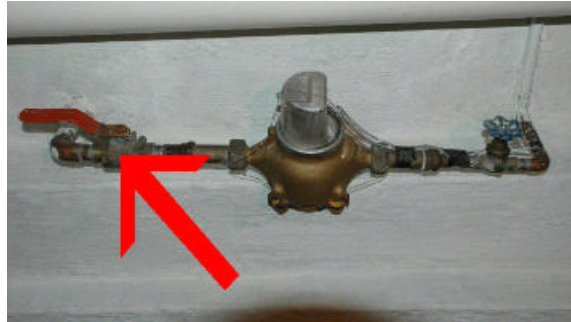
Water Source: City/Municipal.
Plumbing Service Piping Size to Structure: 3/4" water service line from the meter to the main cutoff.
Public Service Piping Material: The main service line to the structure is copper.
Main Water Line Cutoff Location:
